# IONOSPHERIC EXPOSURE FACILITY SPACELABORATORIES HANDBOOK

Science Applications International Corporation

October 1993

Final Report

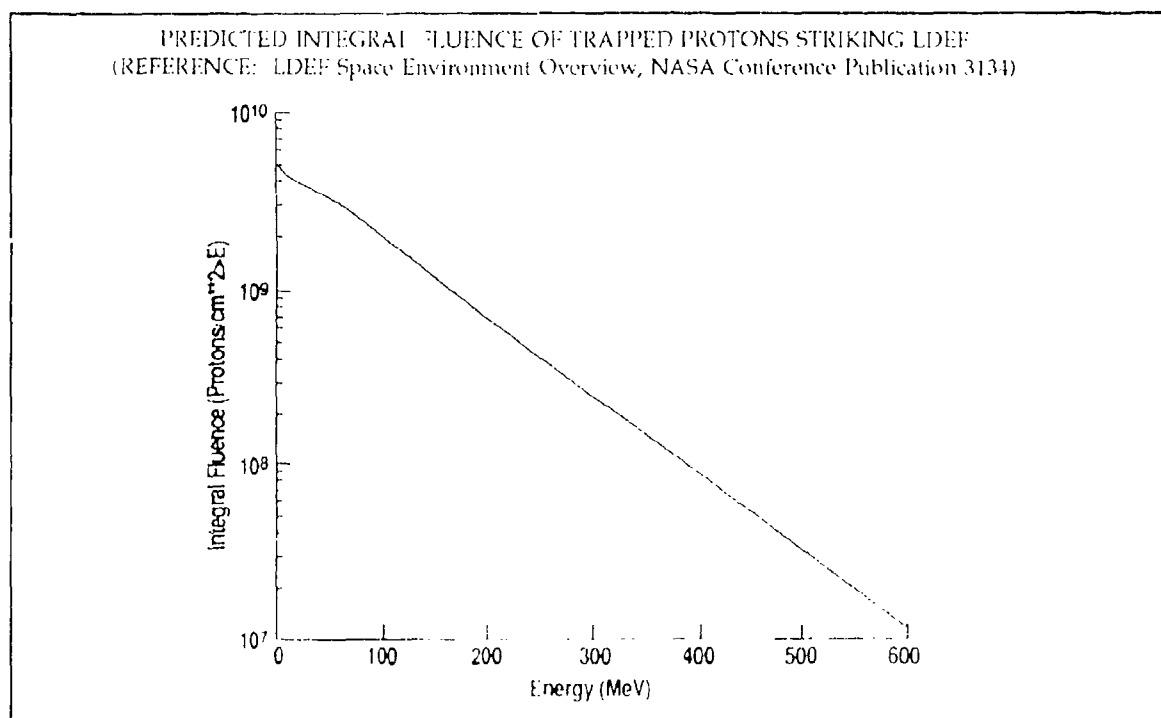
Figure 3.2-6. Predicted Integral Fluence Of Trapped Protons Striking the LDEF

a significant contribution. For the above figures (3.2-3 through 3.2-6), the standard Vette models (Refs. 2-4) were used (together with the associated magnetic field models and the solar conditions). The geomagnetically-trapped electrons dominated the LDEF surface absorbed radiation dose.

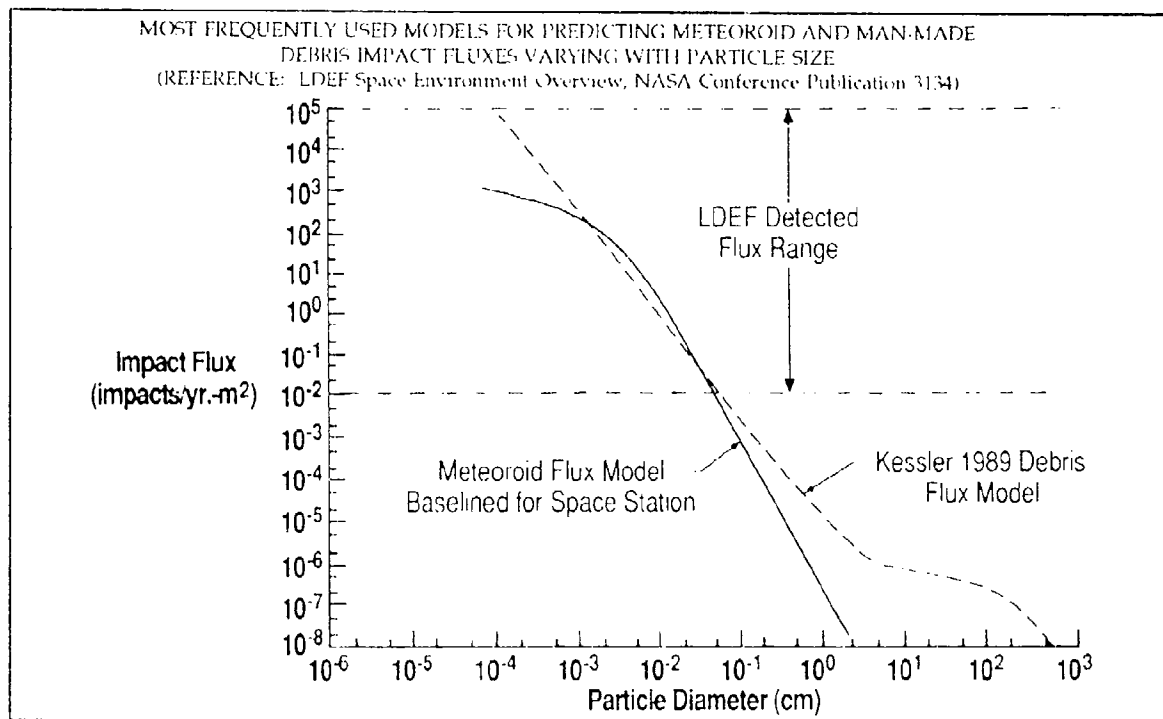
Figure 3.2-7. Most Frequently Used Models For Predicting Meteoroid and Man-Made Debris Impact Fluxes Varying With Particle Size

The current models which are used most frequently to predict natural meteoroid and man-made debris impacts on spacecraft are shown in Figure 3.2-7 (Ref. 1). Based on these models, the largest man-made debris particles or the largest natural meteoroid particles one should expect to have impacted on the LDEF would be approximately 0.5 mm in diameter. An impact of a particle of this size is consistent with the size of the largest crater observed on the retrieved LDEF (Ref. 1). These models also indicate that in the particle size range from approximately 0.02 mm to 0.2 mm more of the impact particles would have been natural meteoroids rather than man-made debris. In the size range less than 0.02 mm in diameter, the models indicate that man-made debris particles should have dominated the impacts.

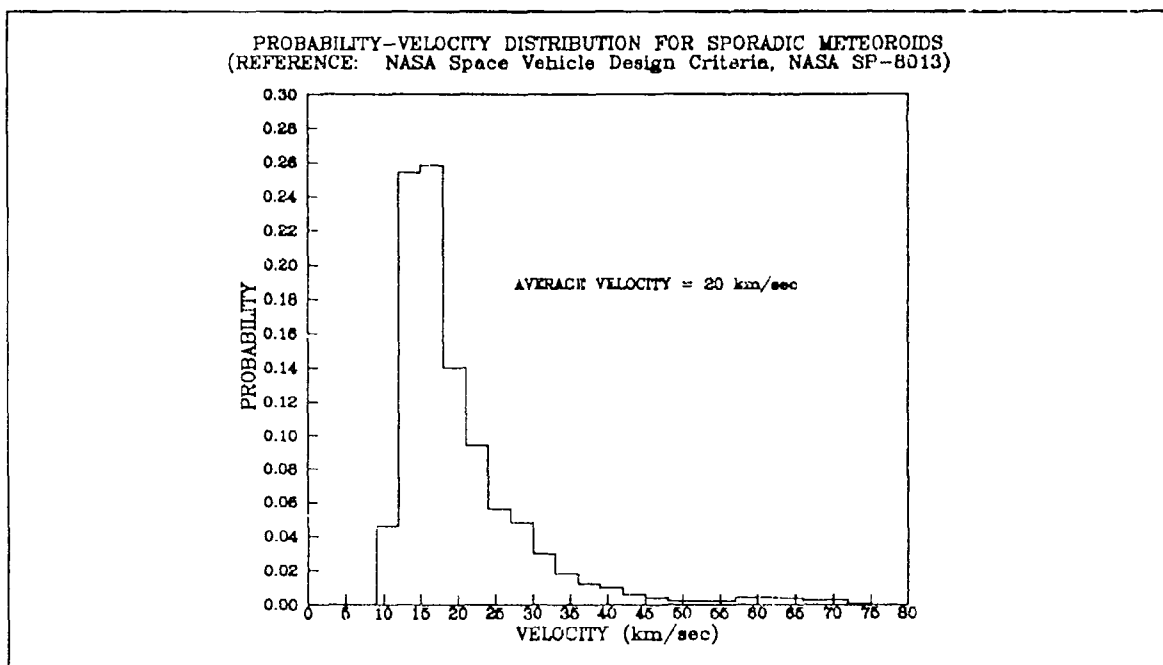
Figure 3.2-9. Velocity Probability Distribution For Sporadic Meteoroids

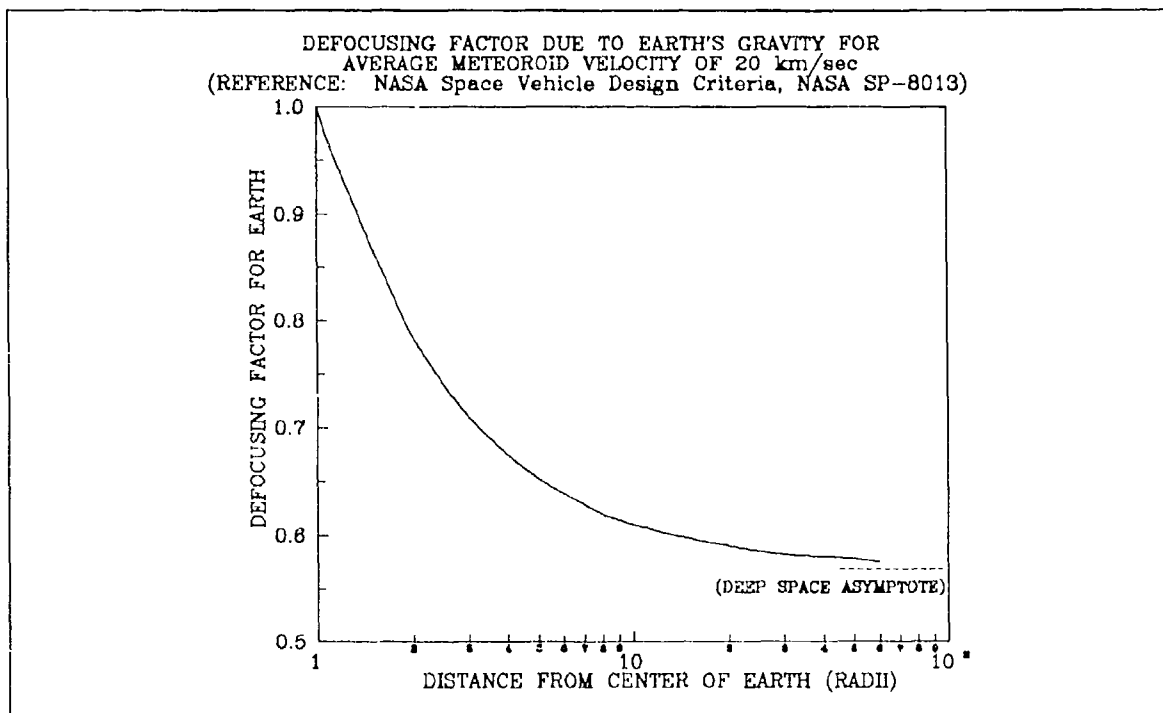
Figure 3.2-10. Defocusing Factor Due To Earth's Gravity For Average Meteoroid Velocity of 20 km/sec.

**3.2.3.1.3 Gravitational Defocusing Factor.** There are two phenomena which influence the actual flux encountered by spacecraft in near-Earth orbits. These phenomena are the gravitational and shielding effects of the Earth and the Moon. The actual number of meteoroid impacts encountered by a spacecraft, obtained from Earth-based observational techniques and orbital direct measurements, is found to have been enhanced by Earth's gravity; i.e., the sporadic flux model is gravitationally-focused. To correct for the Earth's gravitational enhancement at a given distance above the Earth, the average sporadic or total meteoroid flux must be multiplied by the defocusing factor. The factor, as a function of distance above the center of the Earth in Earth radii is given in Figure 3.2-10 (Ref. 10).

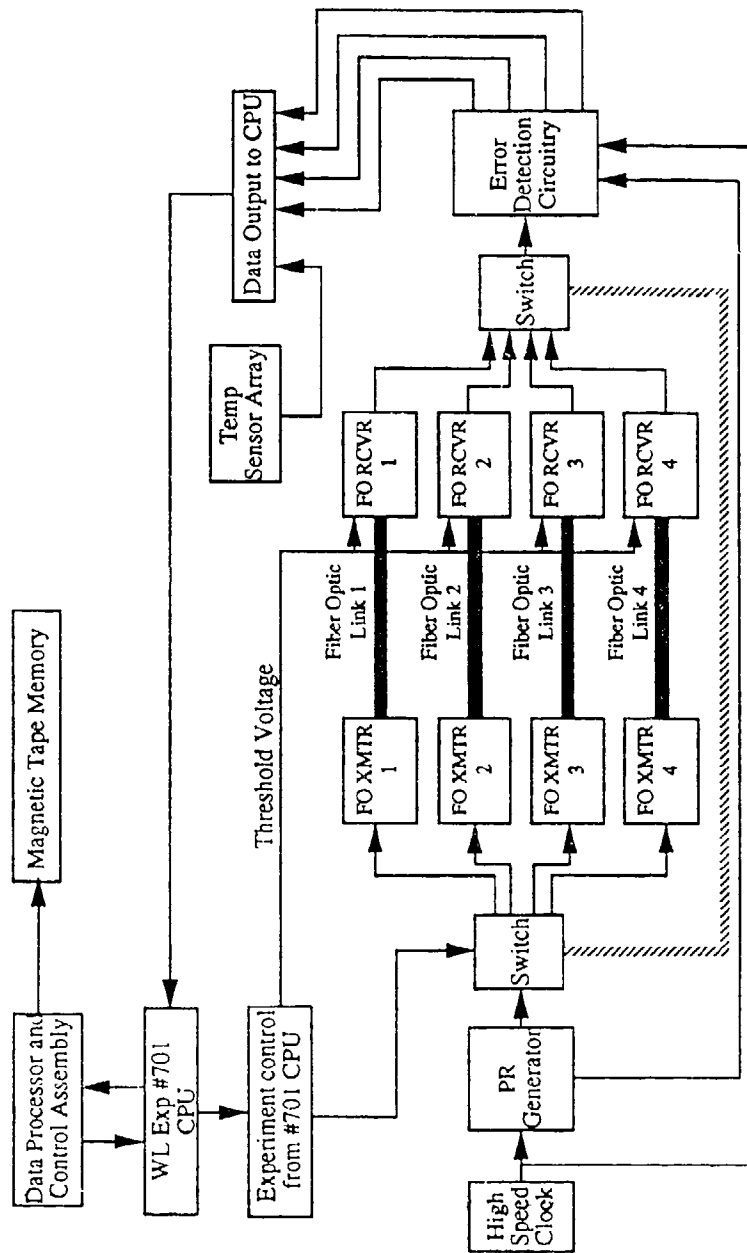
Figure 7-1. Configuration of Experiment hardware. This hardware was used to measure the performance of the four active FO links contained in PL Experiment #701 (M0004). The experiment measured the temperature at various locations within the tray volume and the performance of the FO links by measuring the SNR and BER of each link.

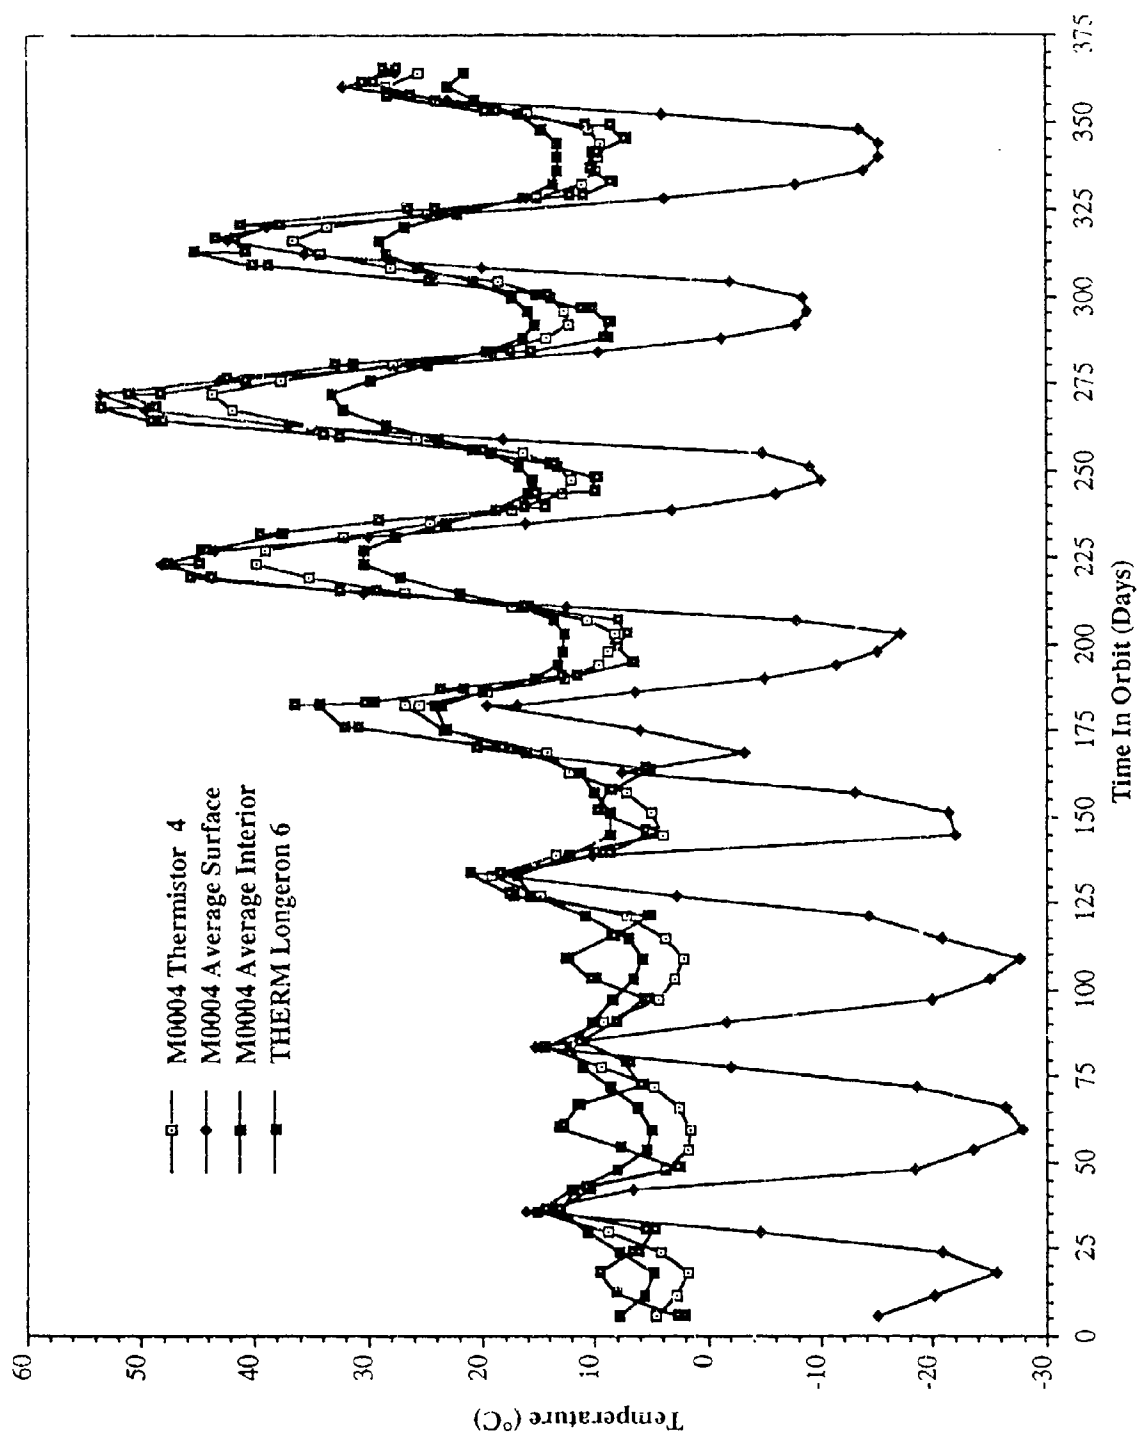
Figure 7-4. Comparison of PL Exp #701 Space Temperature Measurements and Therm Model Data.

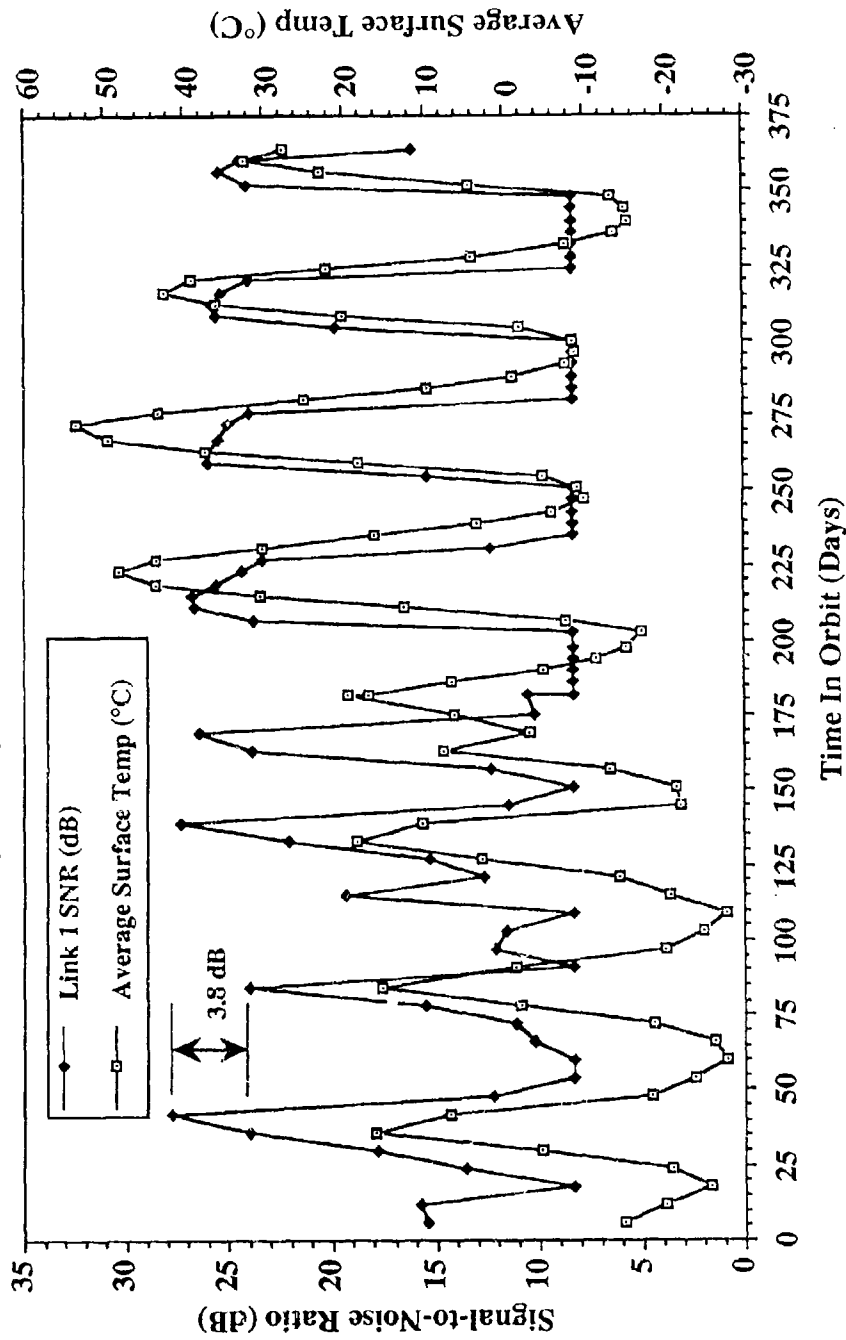
Figure 7-5. Space Orbit Performance of PL Exp #701 FO Link #1.

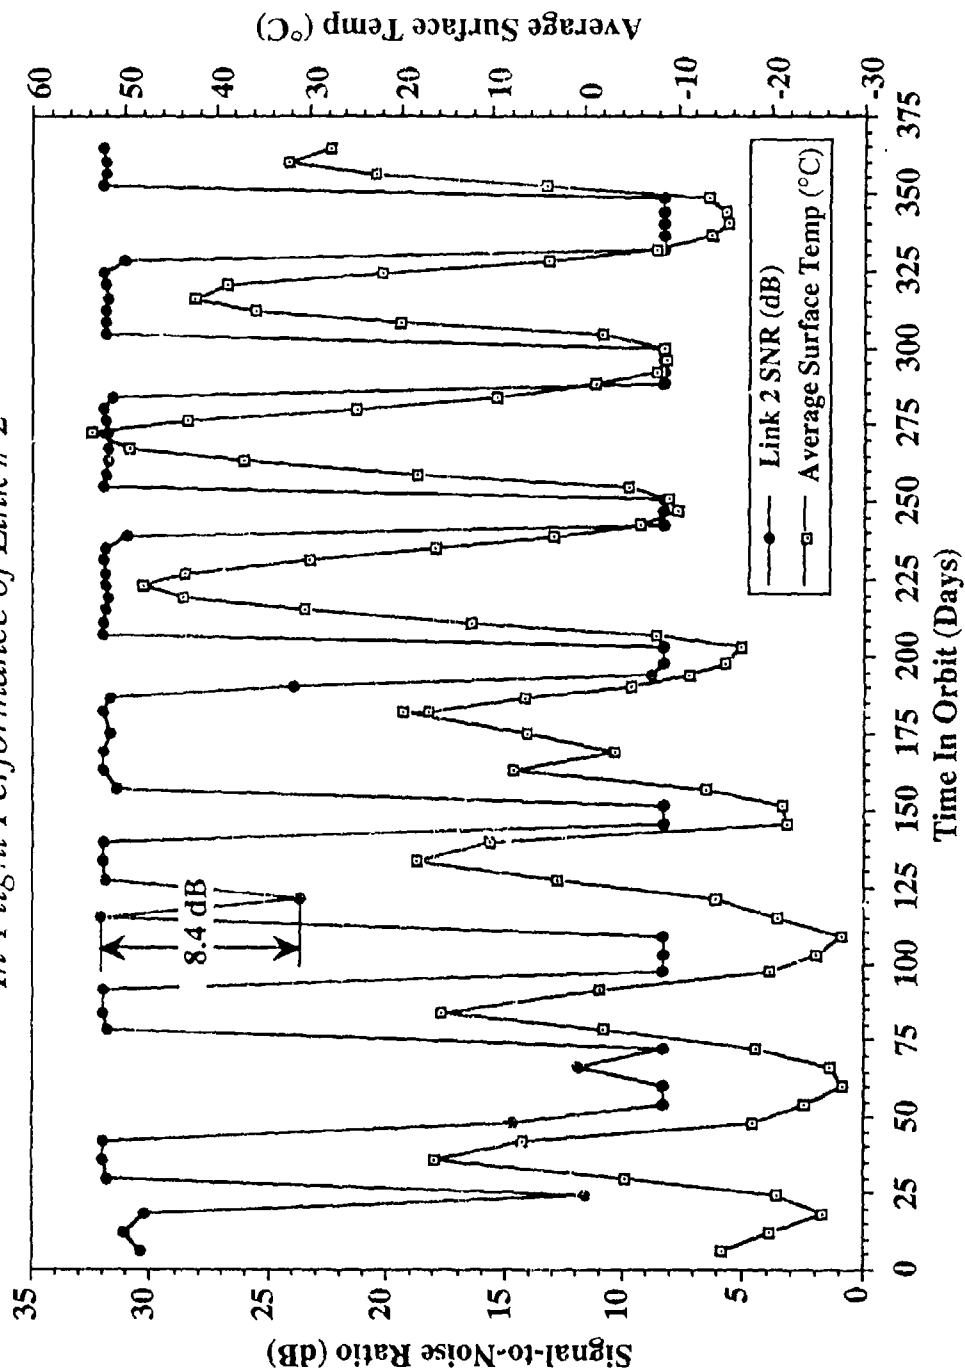
Figure 7-6. Space Orbit Performance of PL Exp #701 FO Link #2.

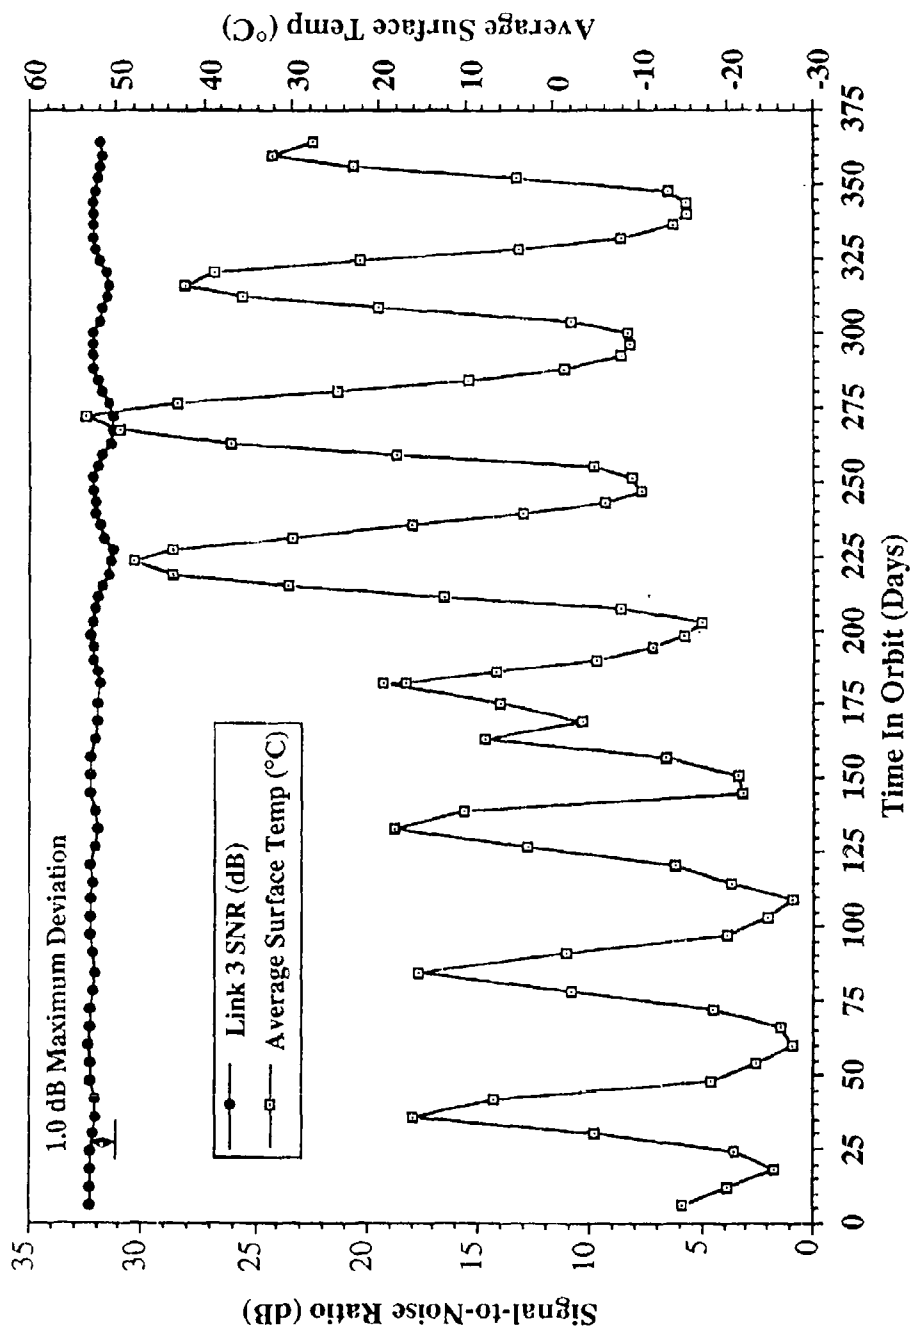
Figure 7-7. Space Orbit Performance of PL Exp #701 FO Link #3.

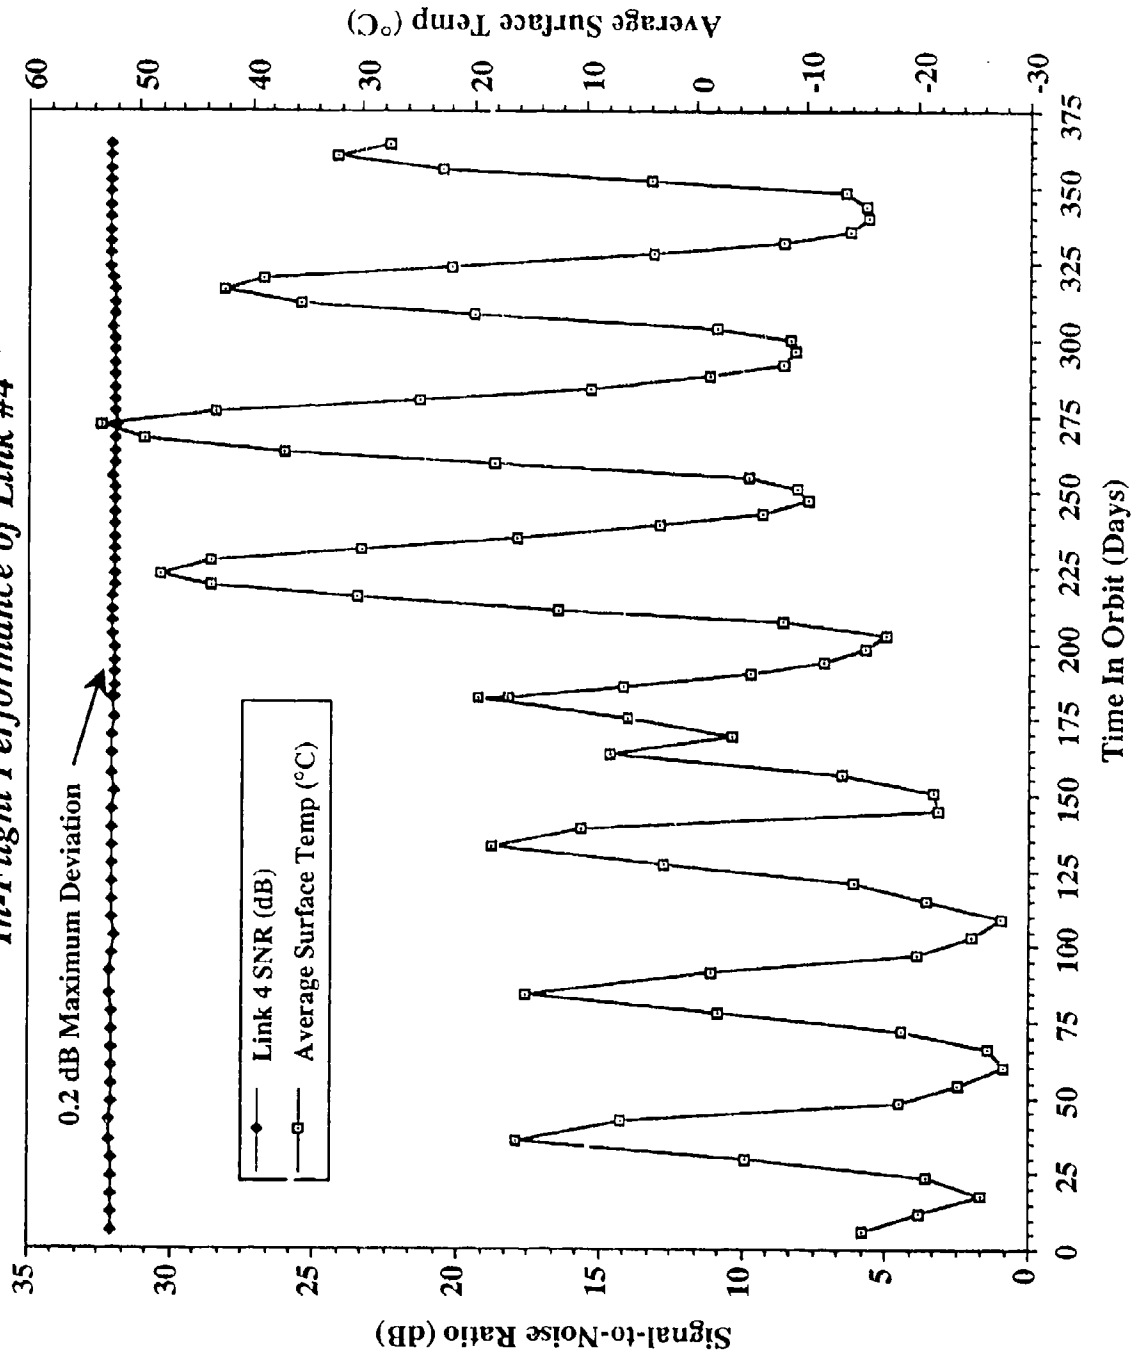
Figure 7-8. Space Orbit Performance of PL Exp #701 FO Link #4.

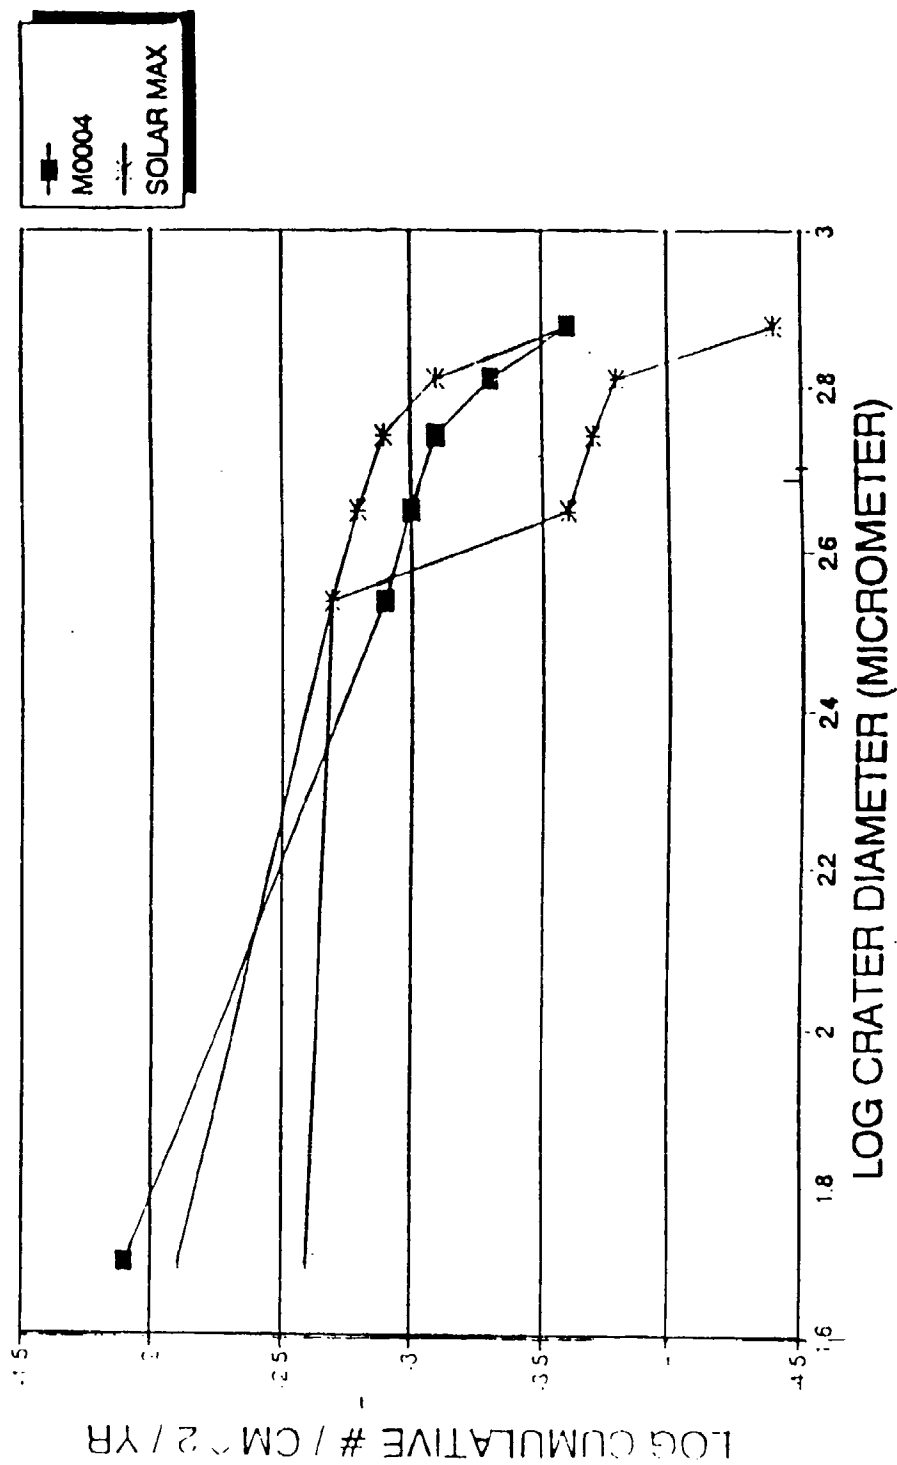
Figure 7-12. Comparison of PL Exp #701 and Solar Max Satellite Impactor Flux Data

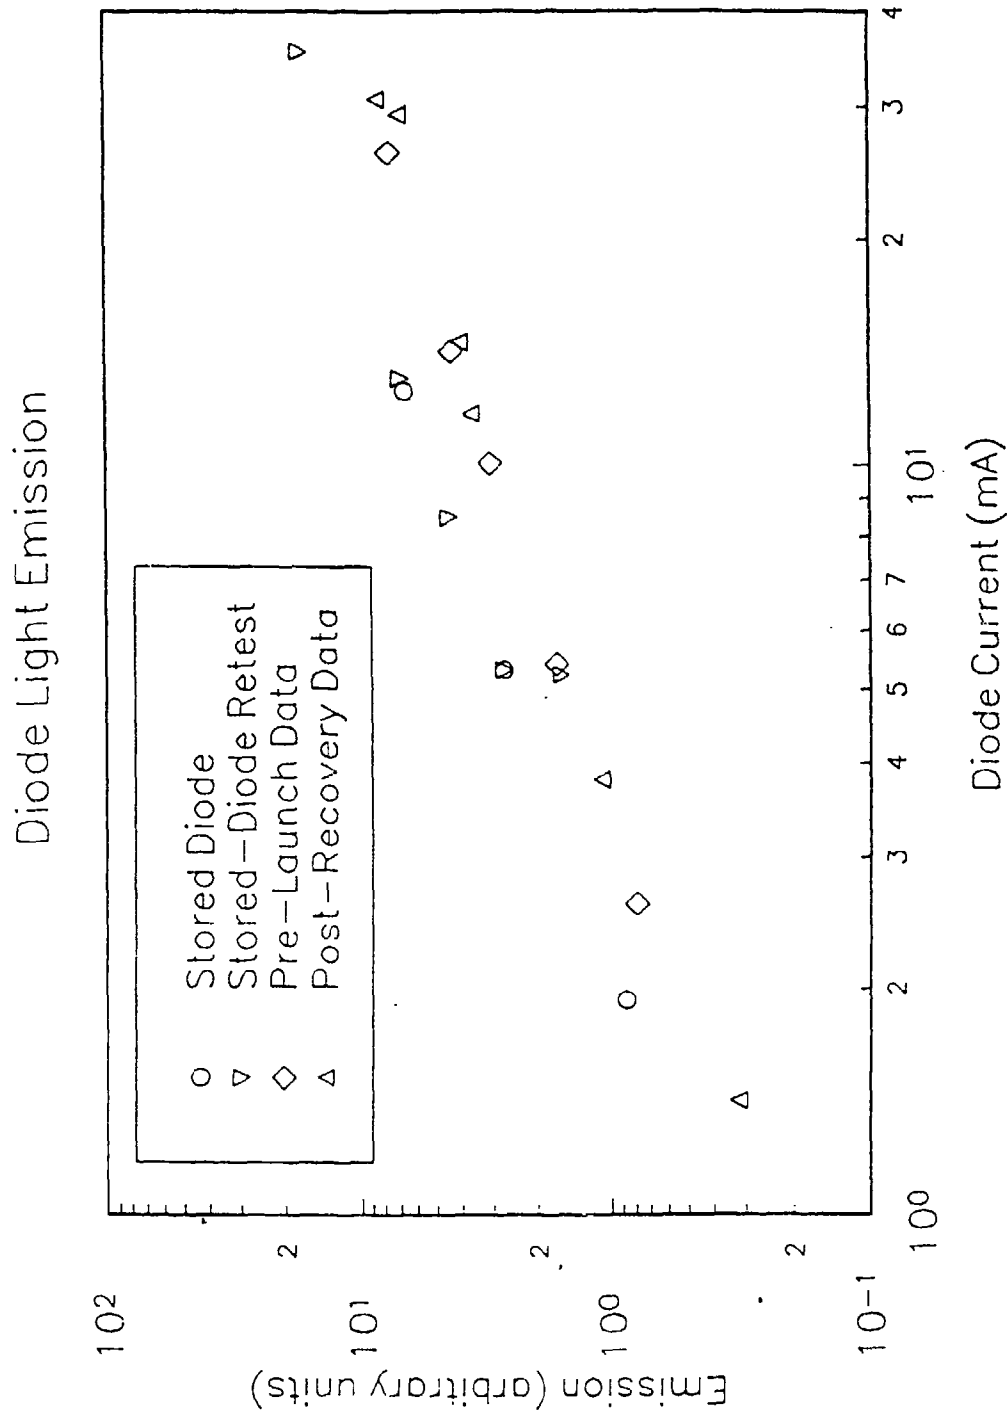
Figure 7-19. Radiation Output vs Forward Current for a GaAsP LED Exposed to the Space Environment and a Stored Diode of the Same Type. The Diodes Reproduce Their Original Characteristics.

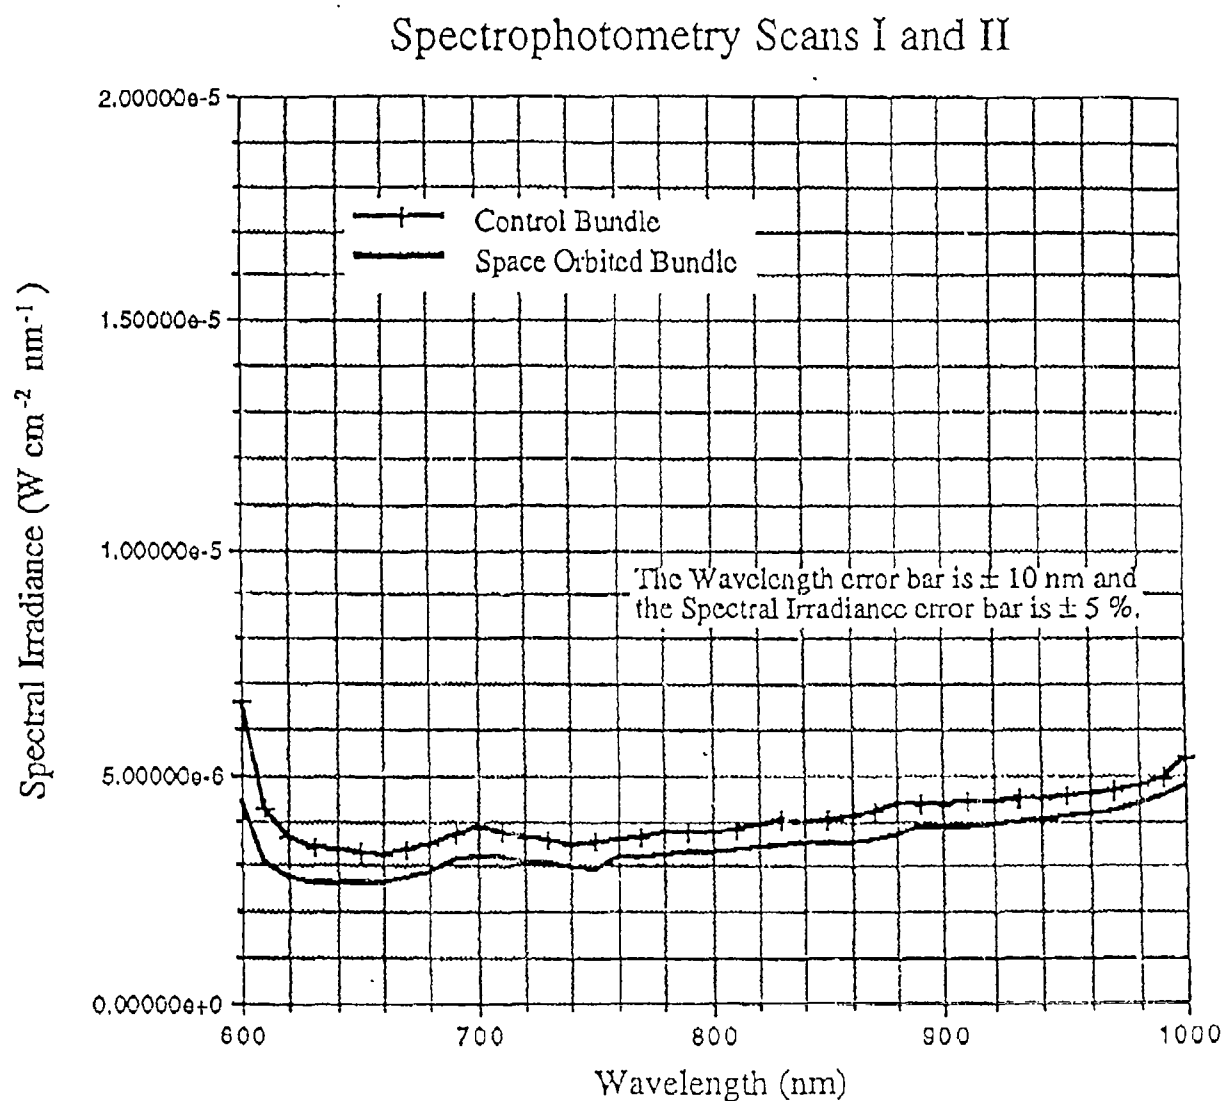
Figure 7-20. The Spectrophotometry Scans I and II have been combined to reveal no significant transmission differences in the comparison of the Control and the Space Orbited FO Bundles.

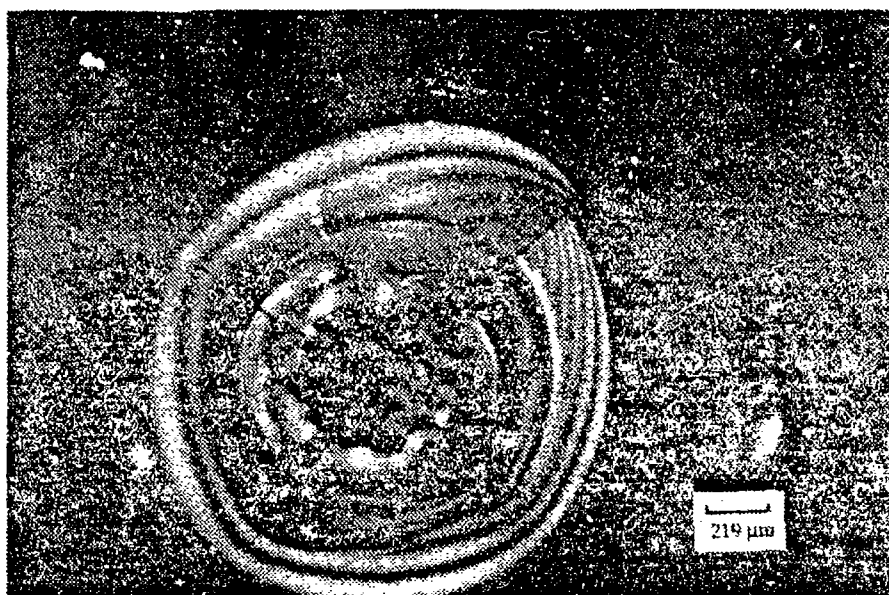
Figure E.2. Impact Effects on 7940 Fused Silica

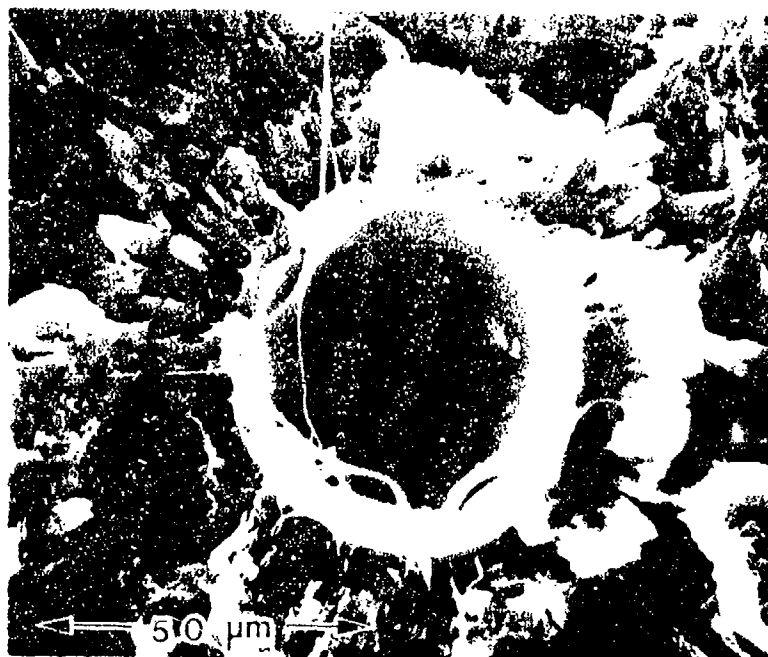
Figure E.3. SEM of Impact on Fused Silica

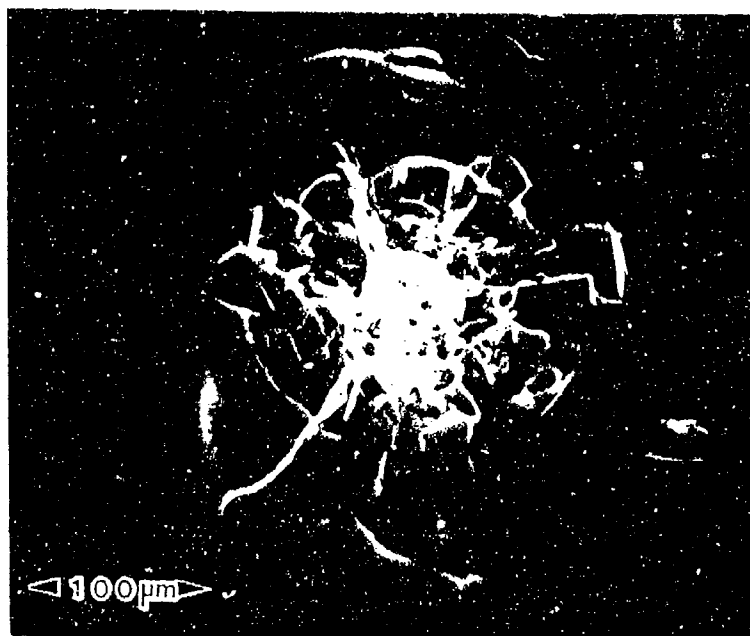
Figure E.5. SEM of Impact on Zerodur

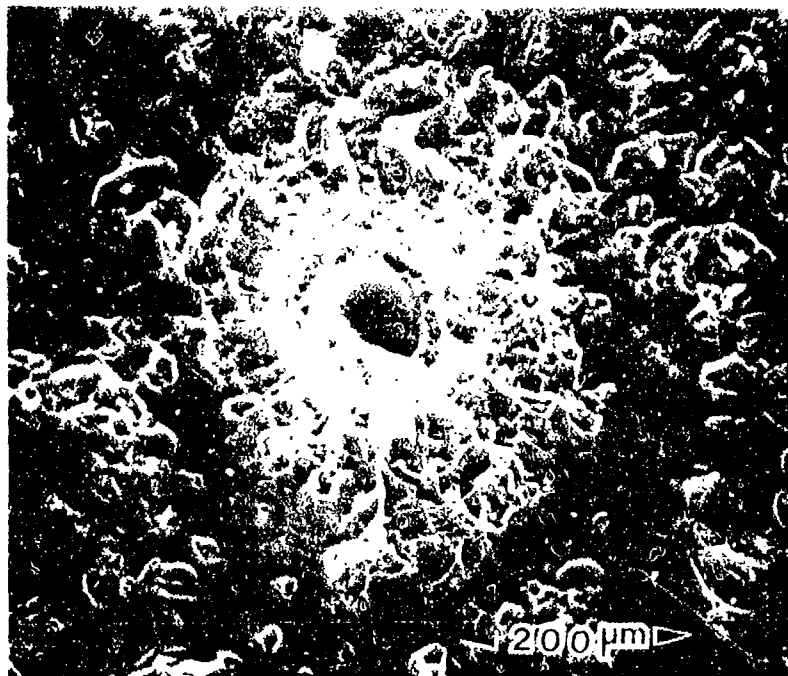
Figure E.6. SEM of Impact on Pyrex

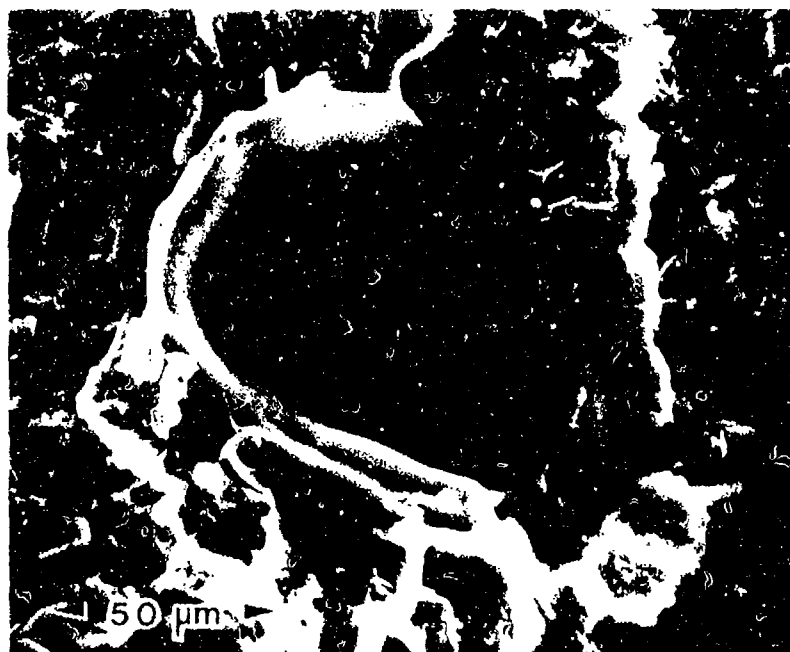
Figure E.7. SEM of Impact on Pyrex

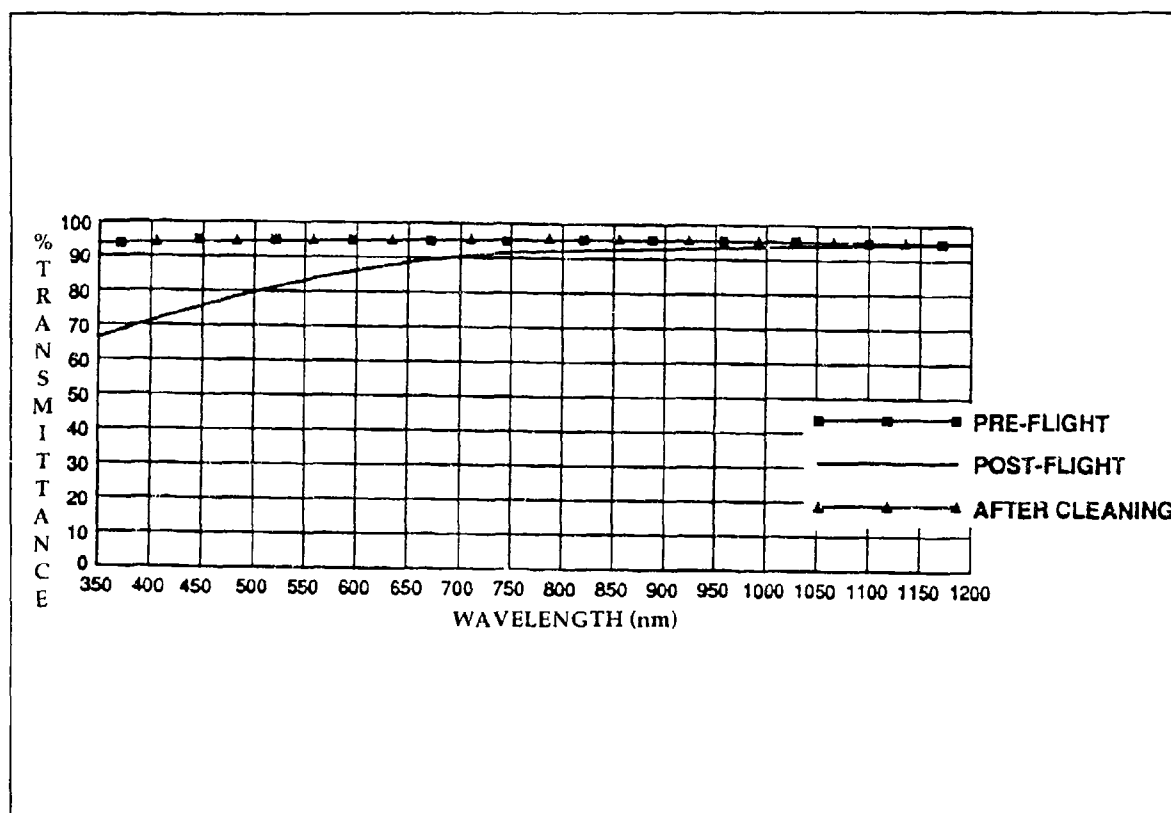
Figure E.10. Spectral Transmission of Uncoated Fused Silica

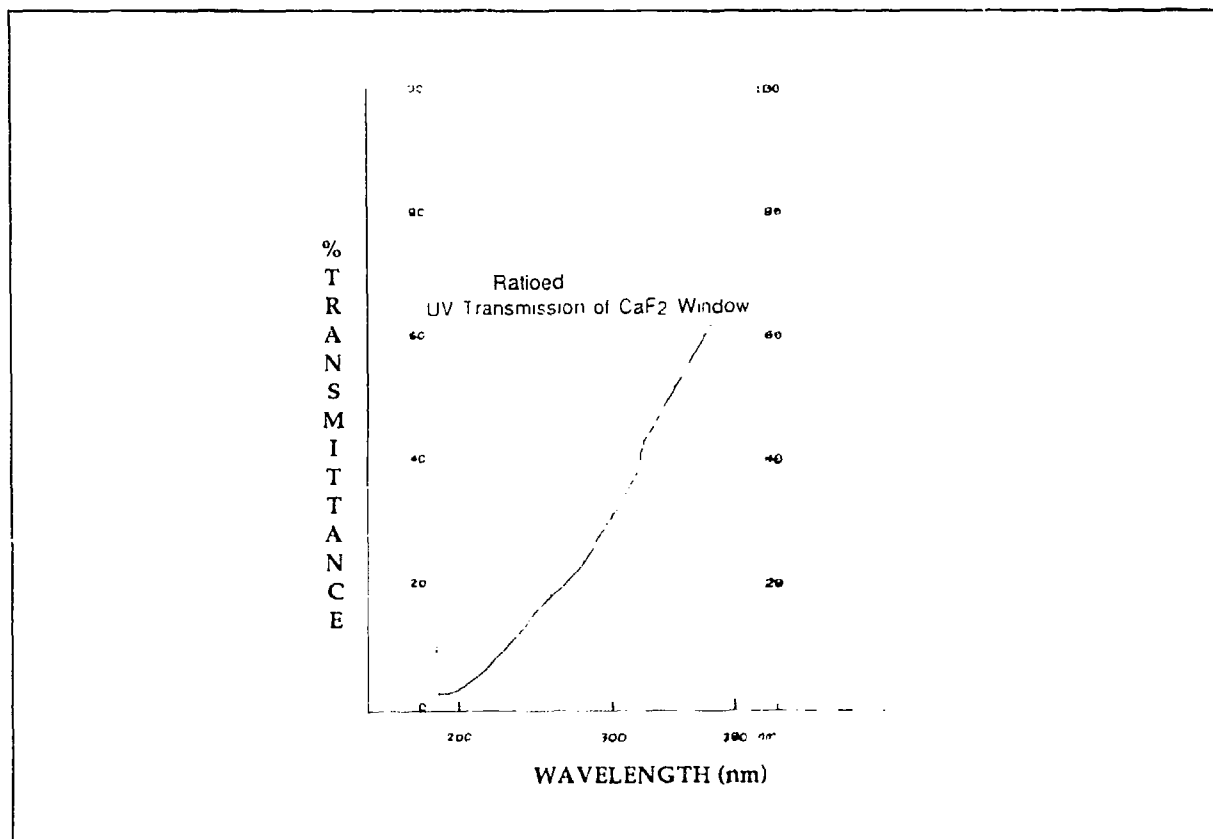
Figure E.12. Ultraviolet Transmission of CaF<sub>2</sub> Window

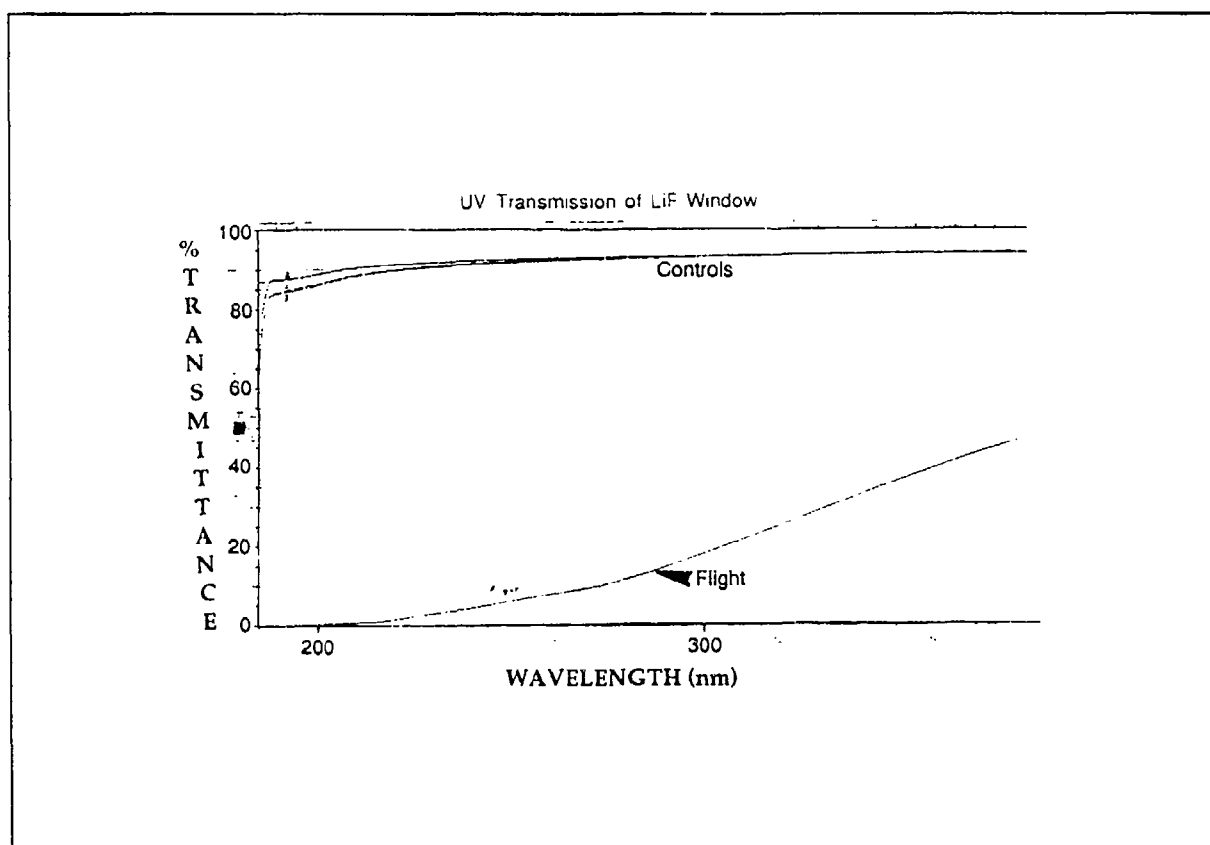
Figure E.15. Ultraviolet Transmission for LiF Window

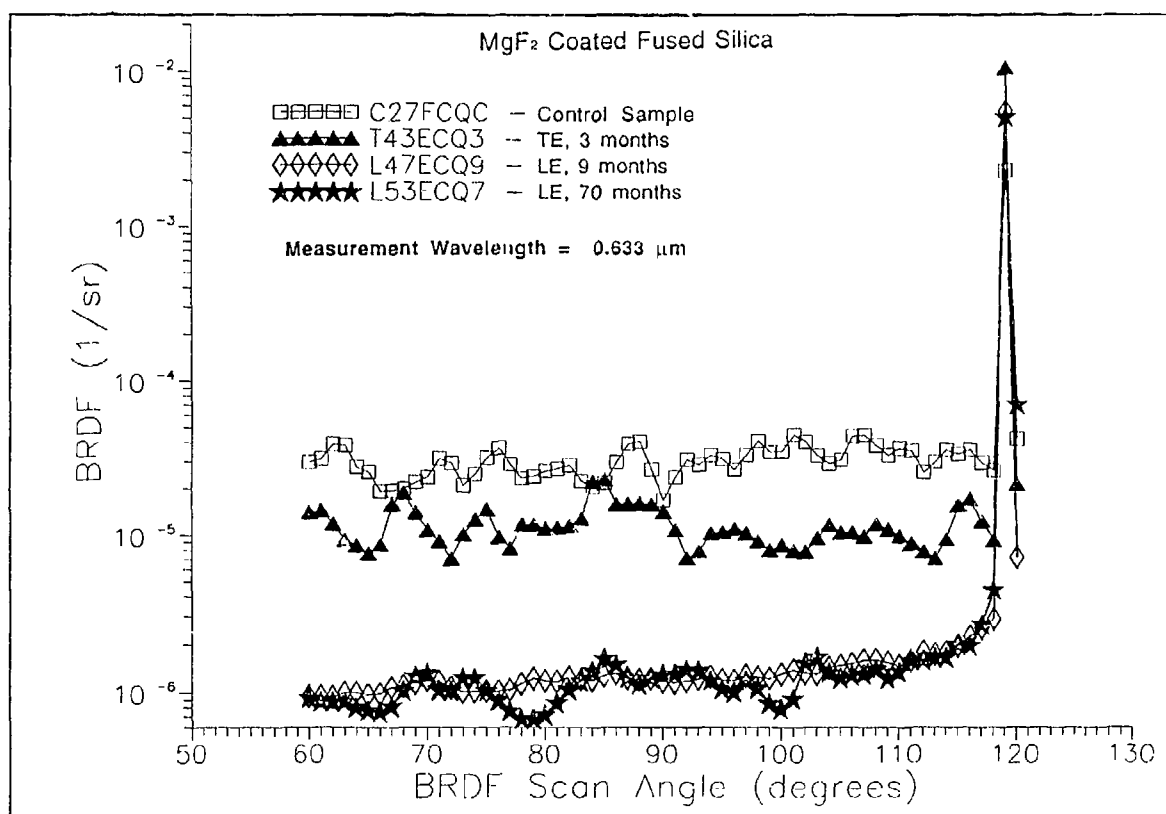
**Figure E.27. Graph of Scattered Intensity vs. Detector Angle for Four MgF<sub>2</sub>/Fused Silica Samples**

<b>REFERENCE:</b>	DeHainaut, Linda L., Kenemuth, John R., Tidler, Cynthia E., and Seegmiller, David W., <u>Degradation of Optical Components in a Space Environment</u> , LDEF Second Post-Retrieval Symposium, June 1992, p. 1361ff.
<b>EXPERIMENT:</b>	M0003-2
<b>COMMENTS:</b>	Leading edge showed less scatter (coating removal by atomic oxygen).
